HELICOPTER SECONDARY STRUCTURES
RELIABILITY AND MAINTAINABILITY
INVESTIGATION

Kaman Aerospace Corporation

January 1974

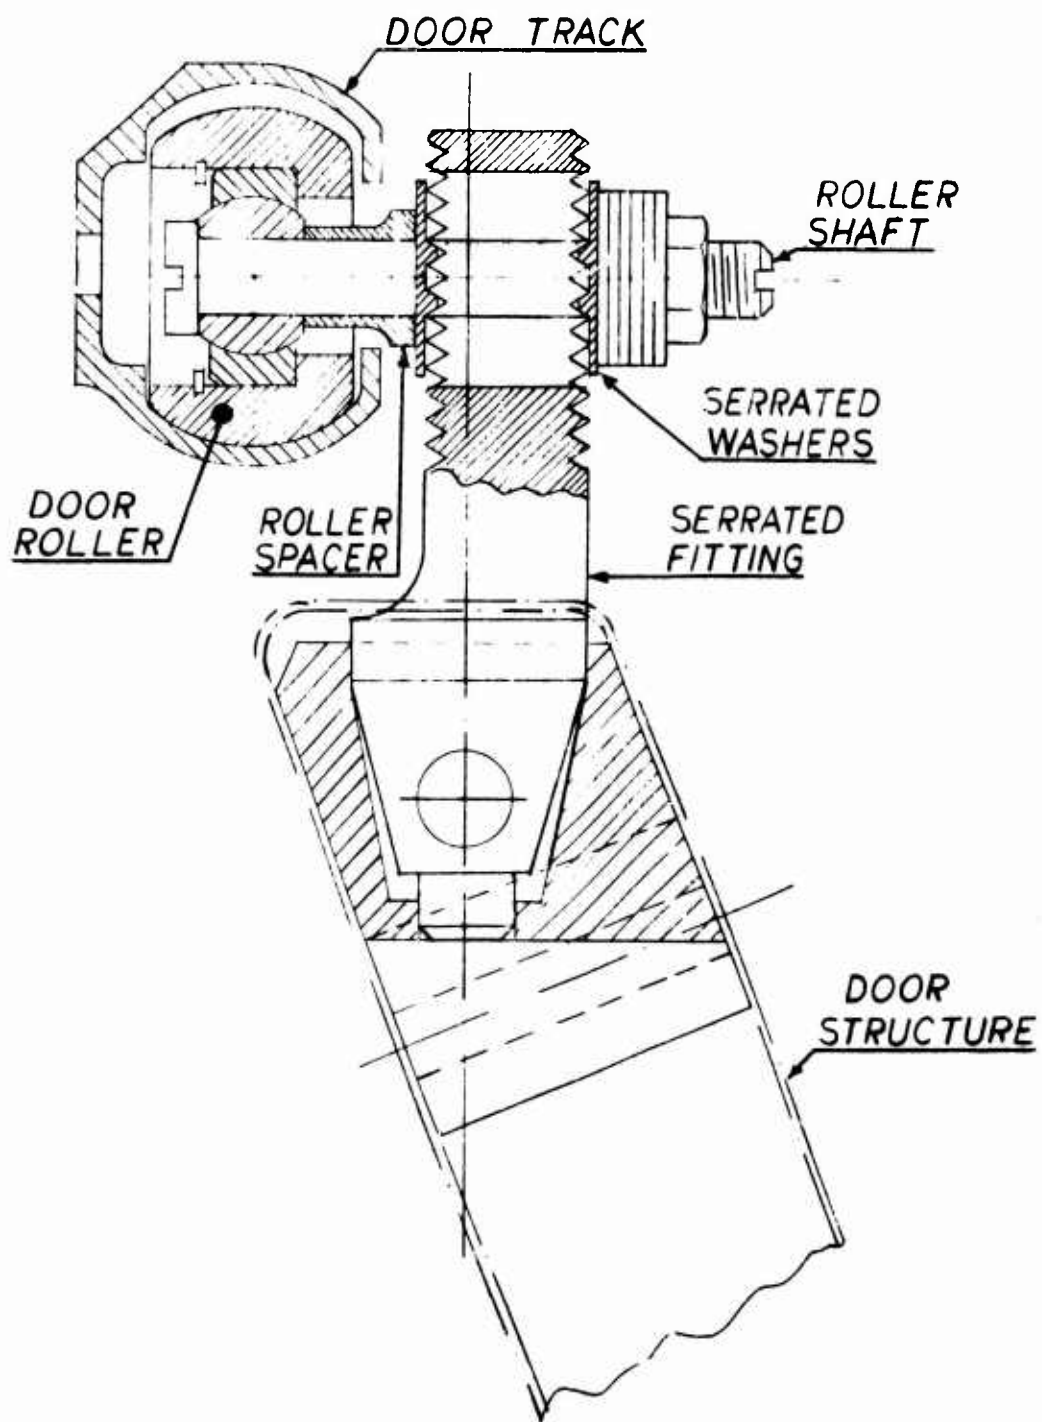
Figure 3. Enlarged Cross Section of Upper Aft Roller Assembly and Track (Pilot Rescue Door).

Ignoring corrosion on the roller assemblies, then, the major problems in the field were reported as worn, cracked and broken rollers. The reported wear on the rollers was readily appreciated, since reference to Figure 3 shows that clearance exists between the outside surface of the roller and the inside contour of the track, and in a vibratory regime as is found on all helicopters, such clearance is translated into relative motion between the parts with consequent fretting wear. The reports of cracked and broken rollers could not readily be attributed to vibration, and so possible causes were sought by further investigation.

Discussions with maintenance and service engineering personnel elicited the information that the write-ups of cracked and broken did not refer to the rollers themselves, but, rather, to the roller spacer and roller shaft shown in Figure 3. It now became easier to understand the cause of these failures.

The current design roller spacer is a thin-walled cylinder having a flange at one end (Figure 3). The wall thickness of the cylindrical section is 0.03". Increasing this wall thickness would decrease the clearance existing between the outside diameter of the spacer and the lower lip of the track, and this was not felt to be desirable. Instead, the roller spacer was redesigned by adding a flange similar to the existing one at the end of the cylindrical portion of the spacer body. This introduced a large flat area in contact with the ball of the roller, and it was felt that this would make the spacer much more resistant to impact failures. This redesigned spacer is shown in Figure 19.

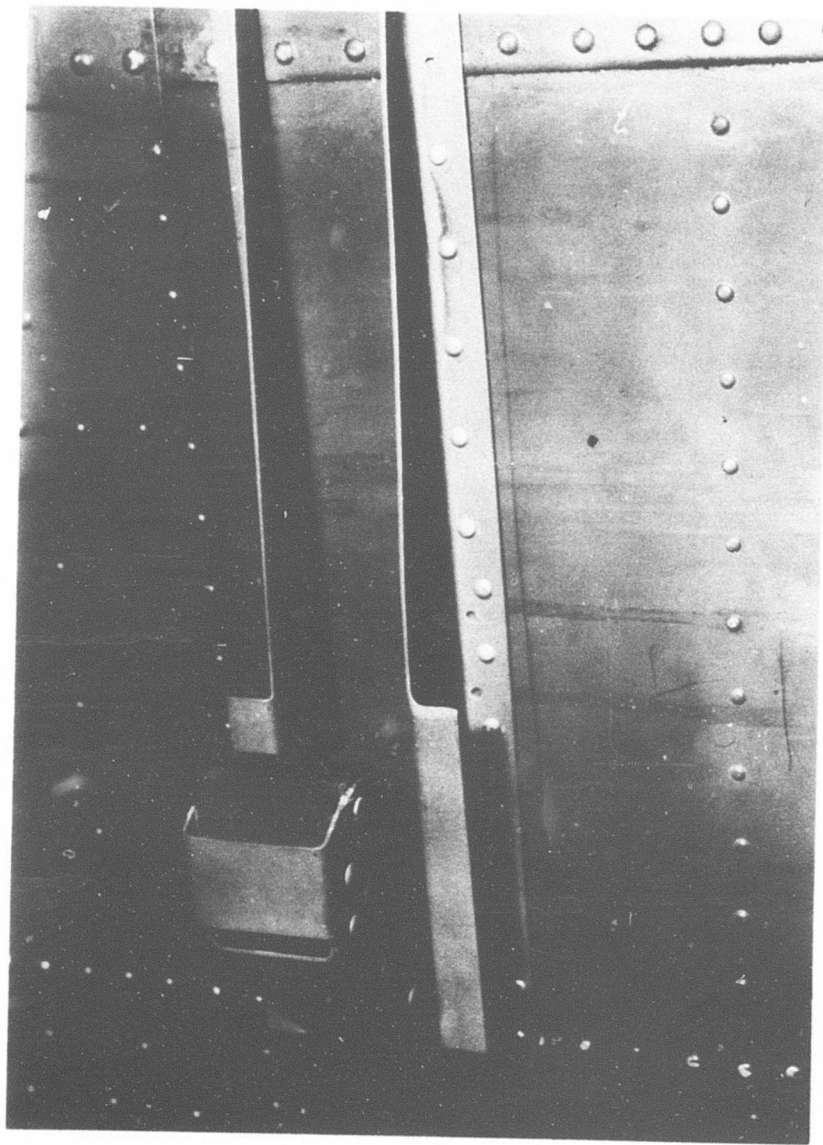
Figure 13. Installation of New External Door Stop (Post-Test).

In order to improve the condition on the roller shaft, it was decided to eliminate the cause of the cantilever loadings to which it is subjected in service. This was done by eliminating the door stop from the track and relocating it. Since it was now understood that the door could be expected to be frequently slammed against the stop, its design and location were given careful consideration. It was finally decided to locate the stop at the approximate waterline location of the C.G. of the door. This location minimizes any cocking action experienced by the door upon impact against the stop. The stop structure, which is illustrated in Figure 13, consists of two tapered channel section members located externally on the fuselage in a waterline plane. Located between these channels and attached to their webs is a tapered box-section member with a generous sized rubber bumper attached to it. One of the channels picks up an existing row of intercostal rivets, and an angle-section intercostal was added to provide backup structure for the other channel. A steel striker plate was attached to the stop contact area on the aft edge of the door (Figure 15) to protect the door sheet-metal structure.

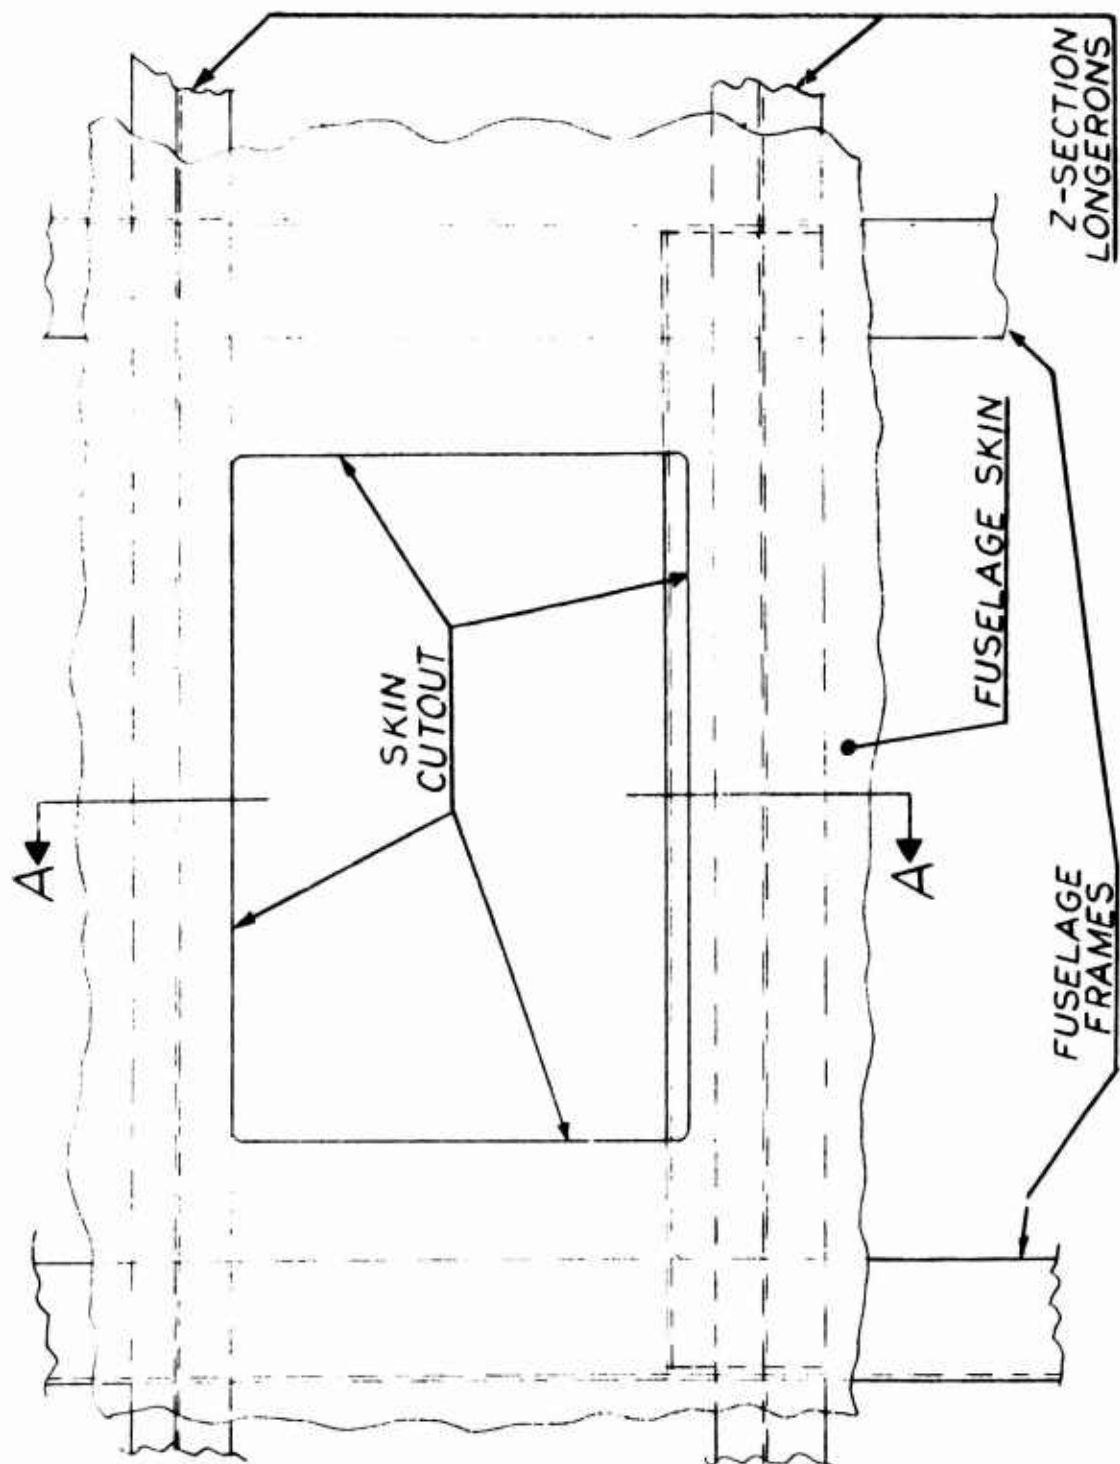
Figure 20. Sketch of Current Design Box Step.

Referring to Figures 20 and 21, it can be seen that the current design is deficient in that it permits the existence of a free edge of the skin cutout in very close proximity to the load-bearing area of the step. This free edge of the thin fuselage skin is very susceptible to scuffing and impact damage. This puts redesign consideration in line with new criteria No. 4, relating to reduction of impact damage on secondary structural components.

Accordingly, the step on the right-hand side was modified by the addition of a doubler to the step area. This doubler is external to the fuselage skin and projects forward and aft beyond the cutout in the skin which forms the box step. The doubler also wraps inboard over the top of the step area. These configurations are illustrated in Figures 22 and 23.

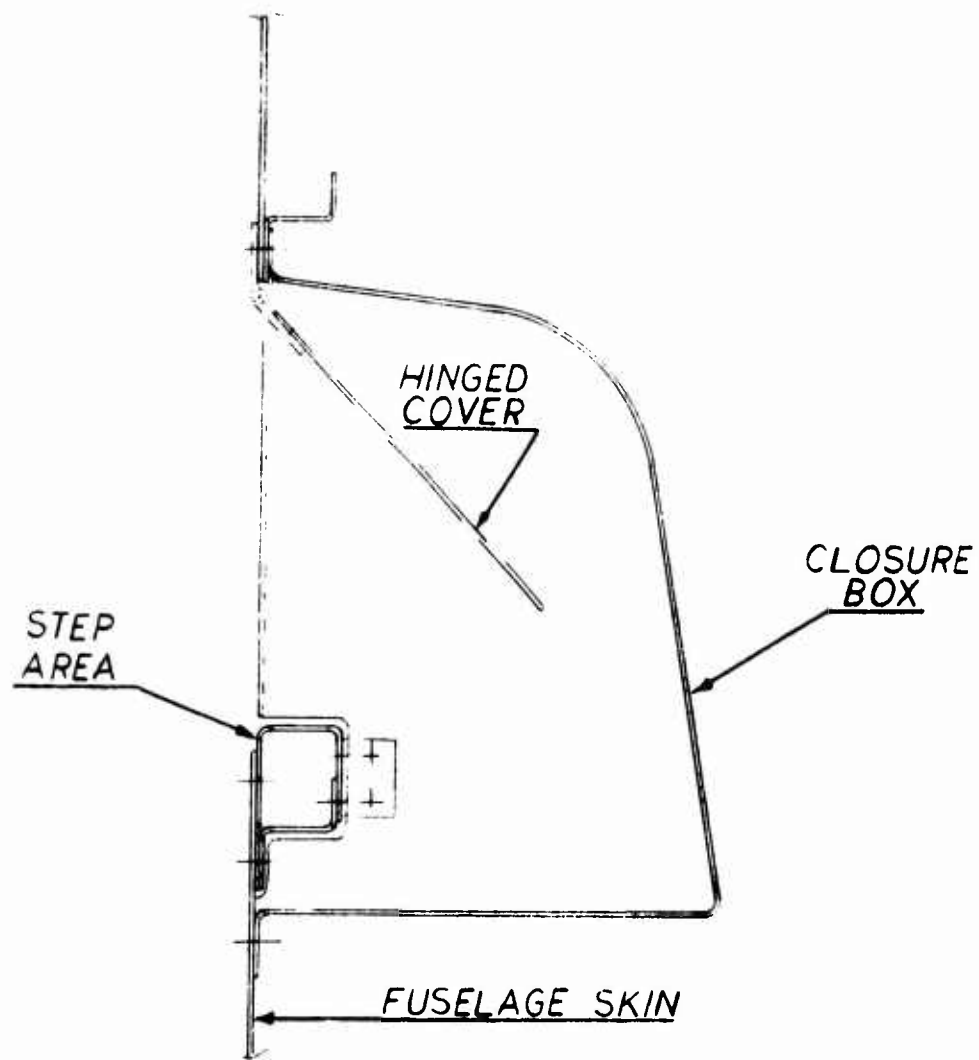
SECTION A-A

Figure 21. Cross Section of Current Design Box Step.

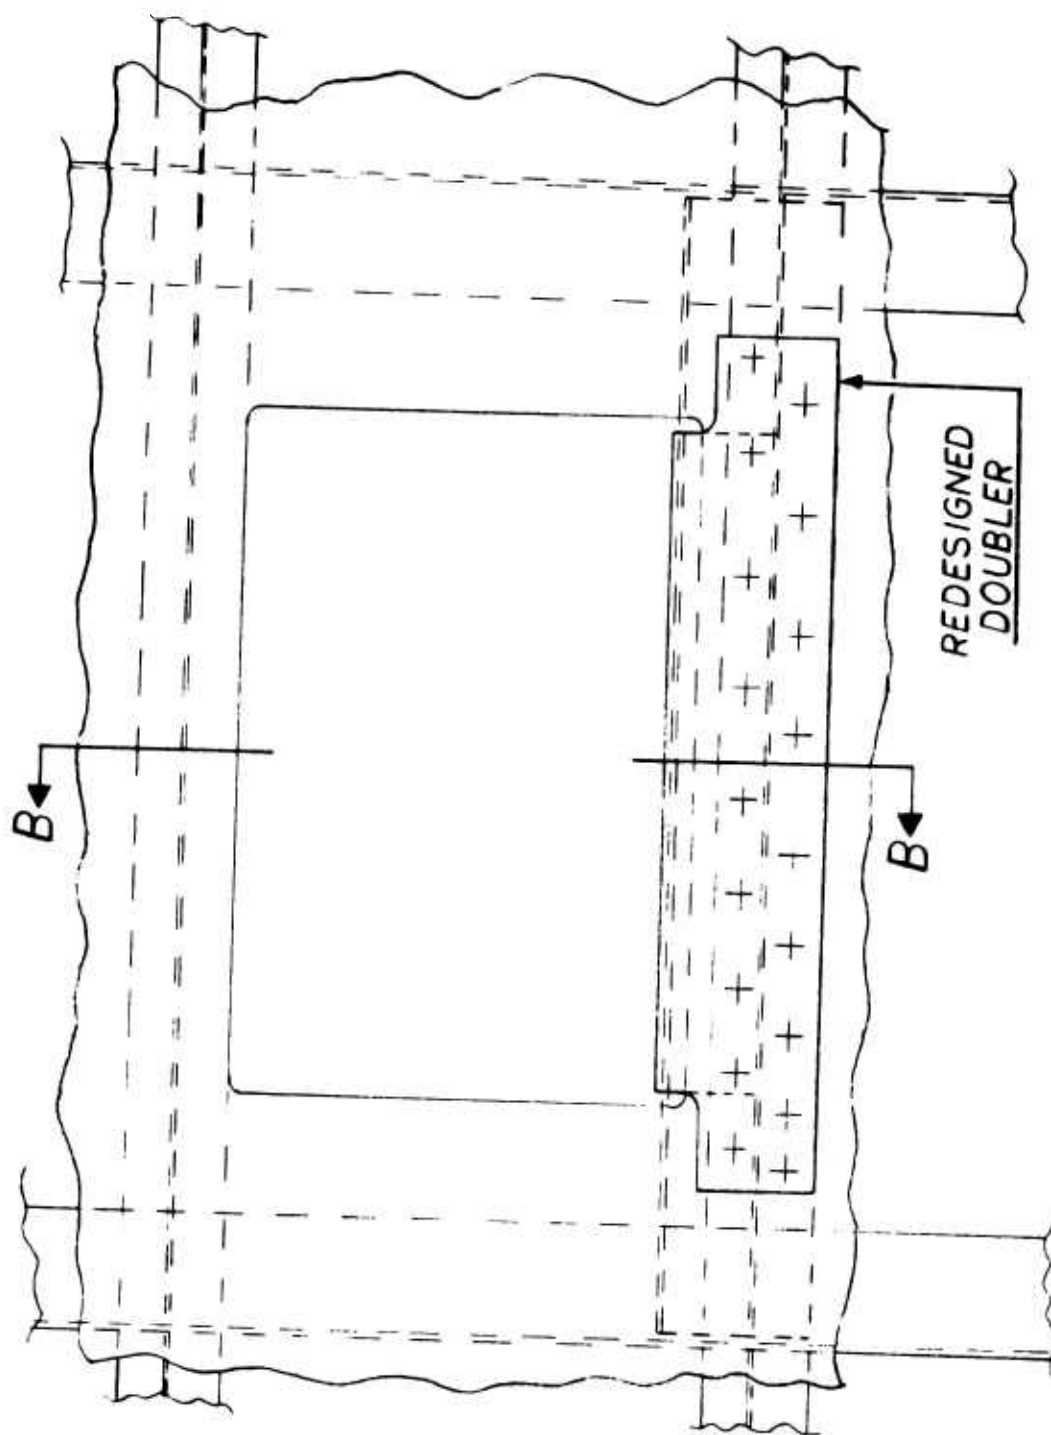
Figure 22. Sketch of Modified Design Box Step.

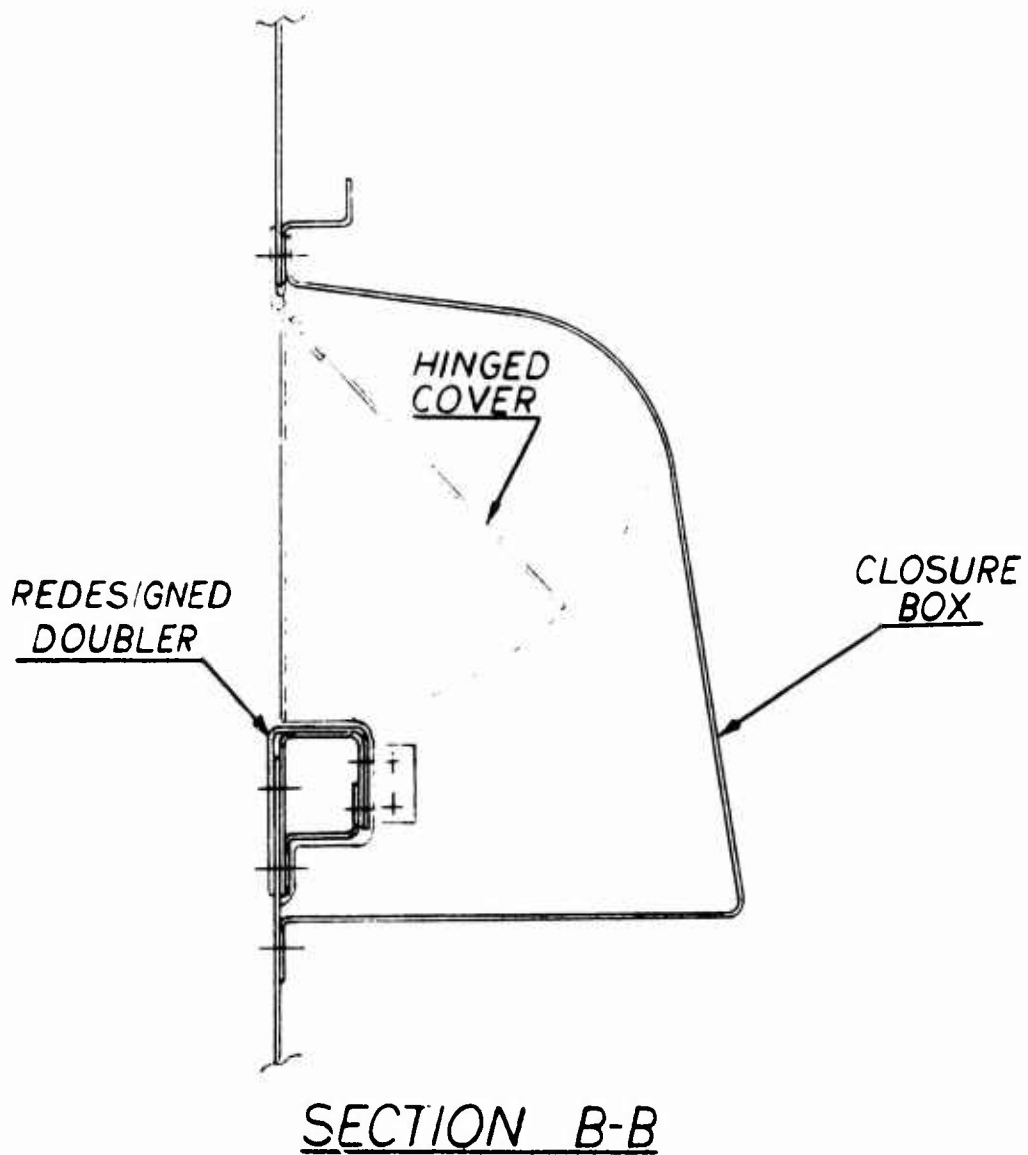
Figure 23. Cross Section of Modified Design Box Step.

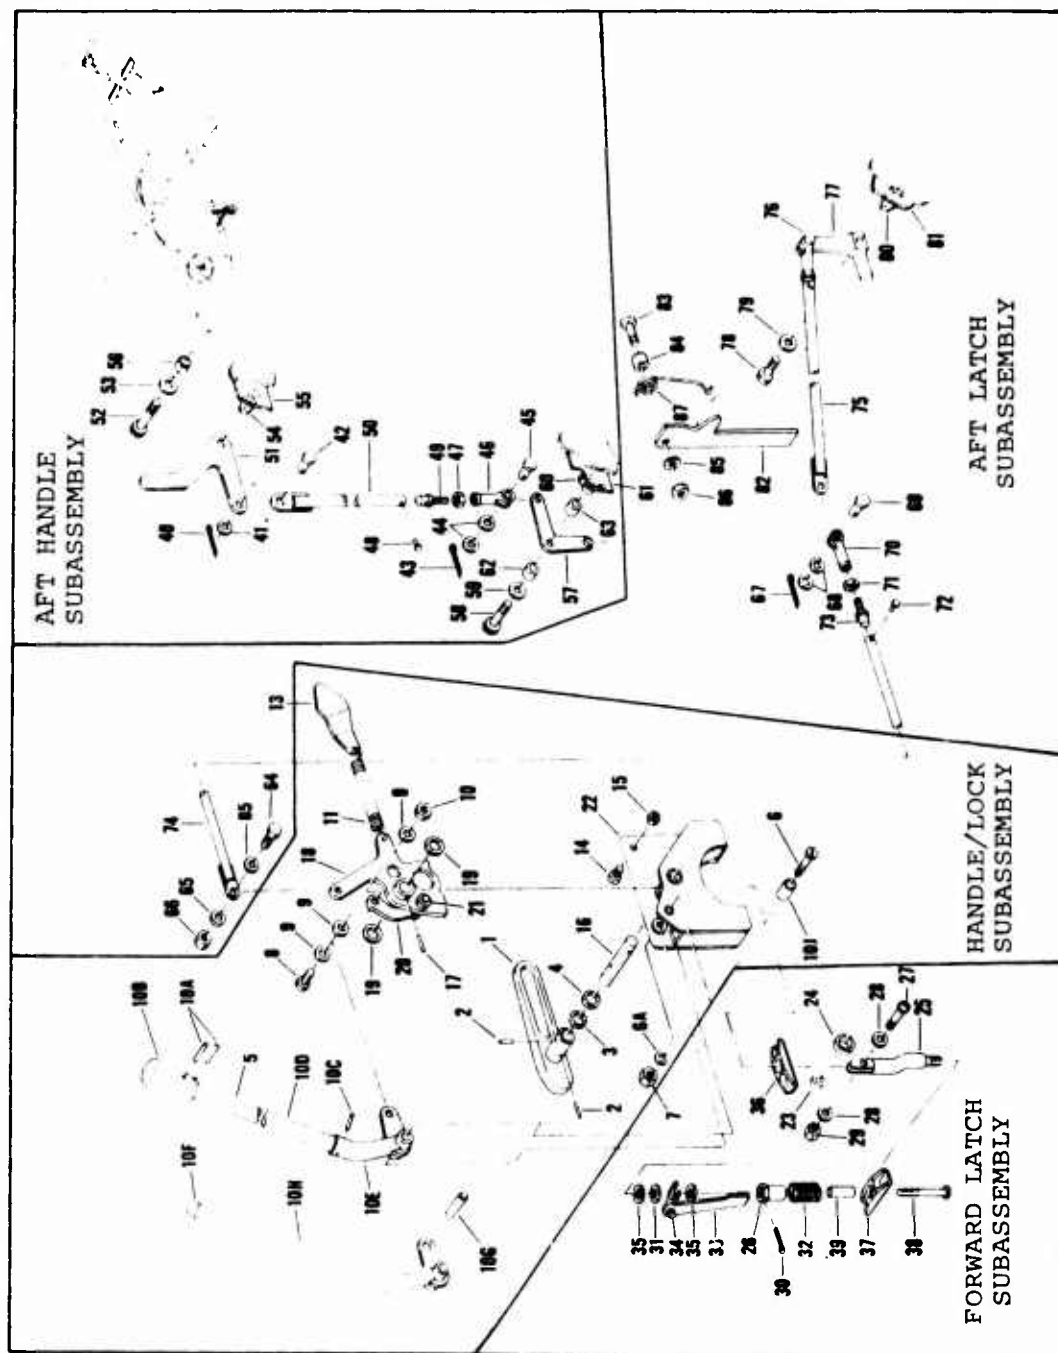
Broken/Bent Parts	33%
Misaligned/Worn Parts	23%
Corroded/Unlubricated Parts ..	8%
Loose Parts	3%

Table VII presents an assembly level FMEA for the handle/lock assembly which was prepared on the basis of the component parts level FMEA of Table VI. Table VII lists functional failure modes predicted for the handle/lock assembly where the possible causes tabulated correspond to the assumed parts failures of Table VI. It is seen in Table VII that the most probable mode of failure for the handle/lock assembly is binding of the mechanism, with jamming of the mechanism and extensive slop in the mechanism also being important failure modes.

Figure 29. Parts Breakdown, Handle/Latch Assembly.

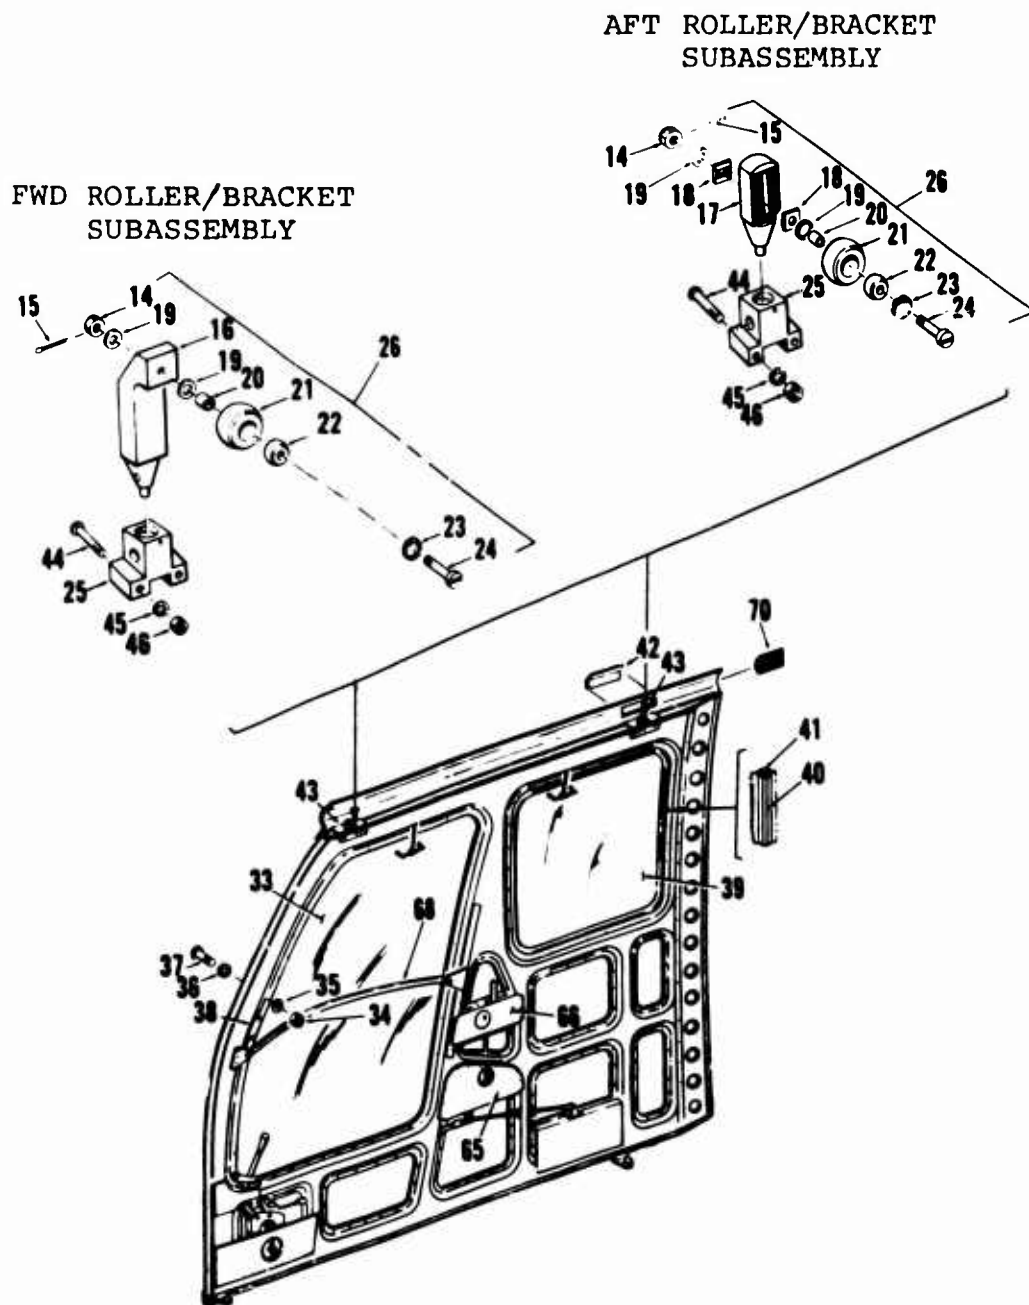
Broken/Bent Parts .:.....	30%
Misaligned/Worn Parts	22%
Corroded/Unlubricated Parts ...	7%
Loose Parts	7%

An assembly level FMEA for the upper roller assembly is presented in Table X. The functional failure modes listed are predicted for the upper roller assembly based on the assumed parts failures of Table IX. Loose rollers appear to be the most probable mode of failure for the upper roller assembly, while broken rollers and rollers out of alignment are also significant failure modes.

Figure 30. Parts Breakdown , Upper Roller Assembly.

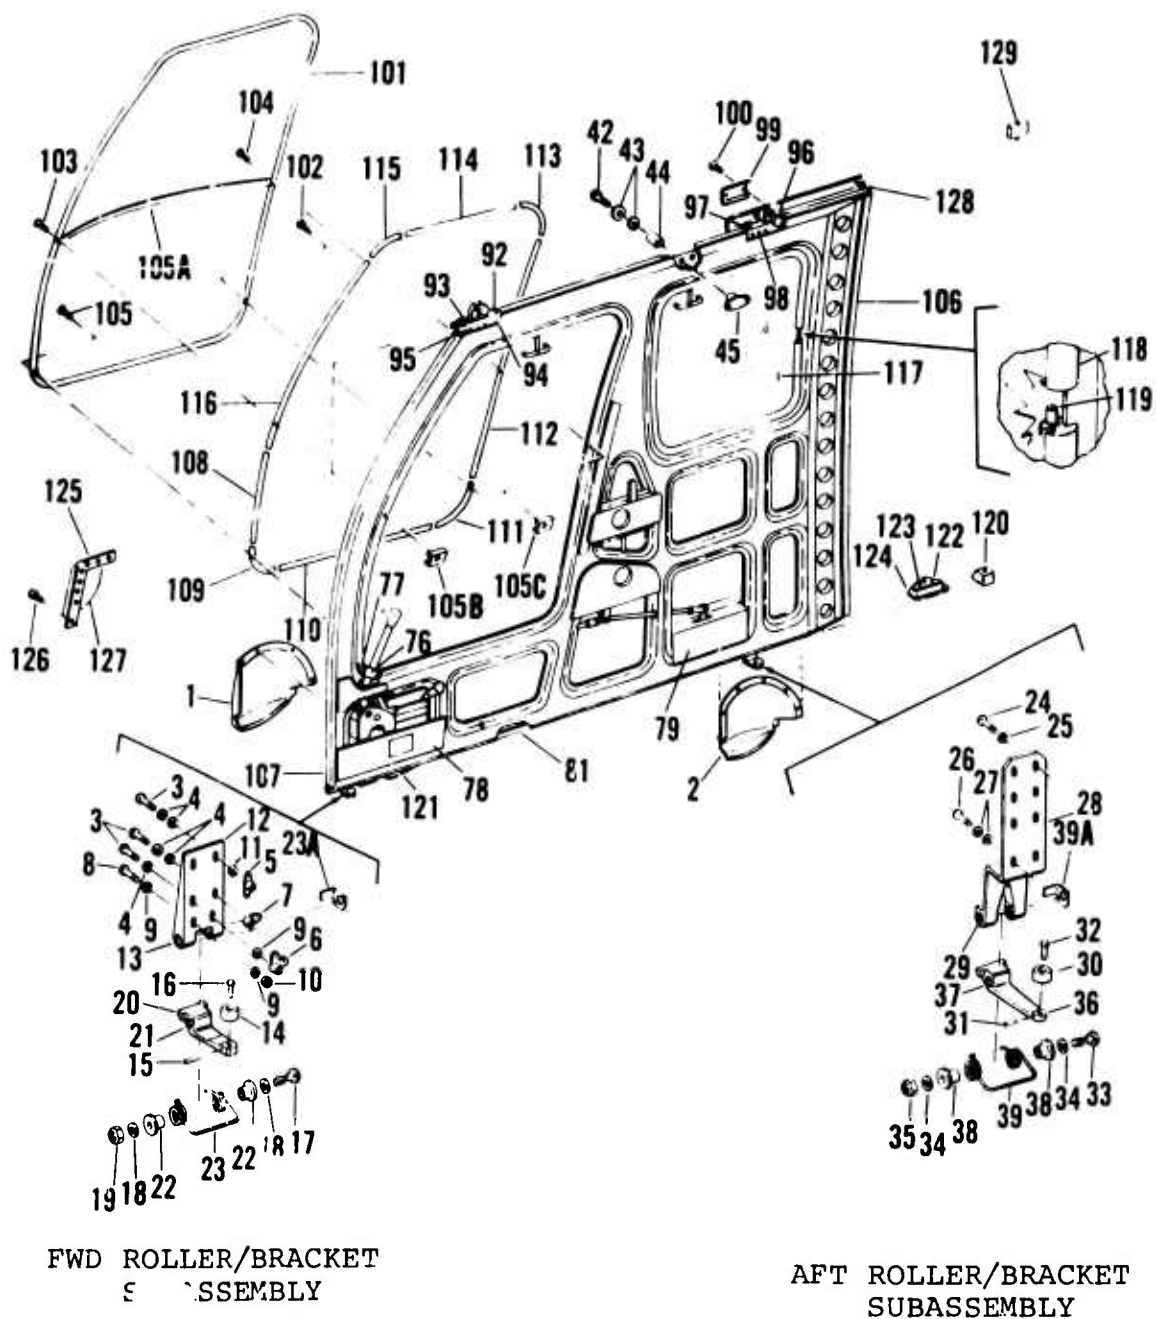
Broken/Bent Parts	26%
Misaligned/Worn Parts	21%
Corroded/Unlubricated Parts ...	10%
Loose Parts	10%

The lower roller assembly level FMEA is presented in Table XII. The most probable functional failure modes for the lower roller assembly are predicted to be excessive roller wear, rollers out of adjustment, and broken rollers.

Figure 31. Parts Breakdown, Lower Roller Assembly.

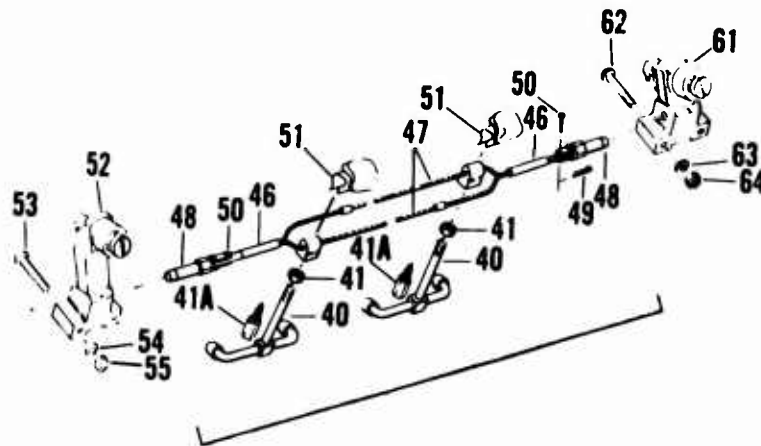
Broken/Bent Parts	34%
Misaligned/Worn Parts	11%
Corroded/Unlubricated Parts ...	22%

The FMEA of Table XV indicates that the most probable causes of door jettison subassembly operational failures are broken cables and corroded pip pins.

Figure 32. Parts Breakdown, Door Jettison Subassembly.

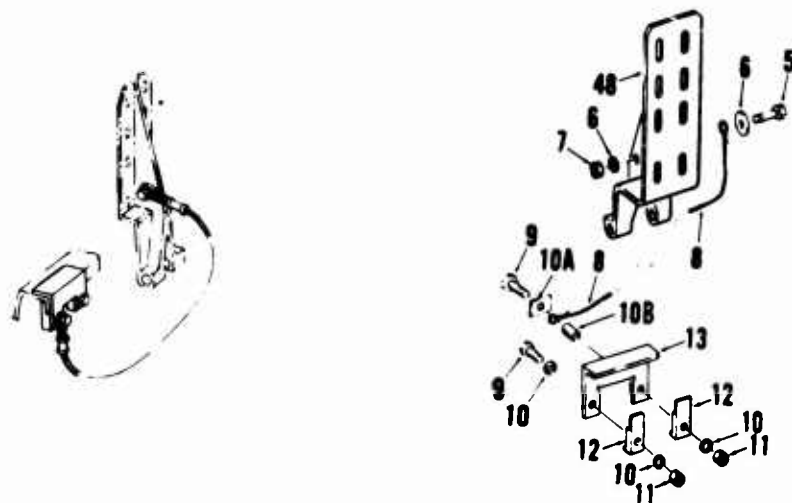
Broken/Bent Parts	40%
Misaligned/Worn Parts ...	13%
Loose Parts	13%

From the FMEA of Table XVII, the most probable causes of operational lanyard subassembly failures are predicted to be broken lanyards and bent fittings due to improper installation and rough handling.

Figure 33. Parts Breakdown, Lanyard Subassembly.
